Altimeter Tune Up

RAA

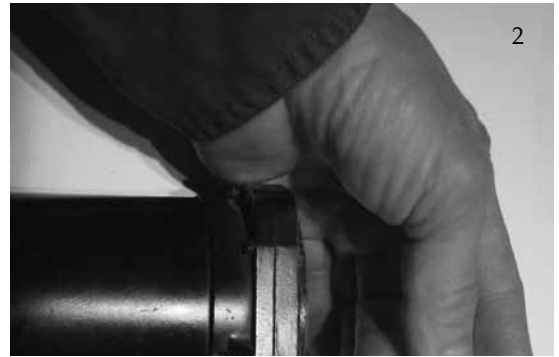
Fig 2: insert a paperclip or a small screwdriver into the threaded hole and slide the pin outwards. It will probably be stiff, but it will click and move 1/16". This frees the adjusting knob.

Now that the face screw has been removed the pin can be slid out about 1/16" using a paper clip or a small jeweller's screwdriver. This will then release the adjuster knob and it can be pulled away from the altimeter about 1/8", which is enough to release its gear from the altimeter geartrain. It will still be engaged with the geartrain for the Kollsman window, so you can just turn the Kollsman window to the current setting number.
