## Altimeter Tune Up

SOME ULTRALIGHTS have altimeters that do not have the correct relationship between the altimeter pressure setting in the Kollsman window and the field elevation. Typically the pilot sets the field elevation and just goes with that because the flights are an hour or so and the landing is at the home field.

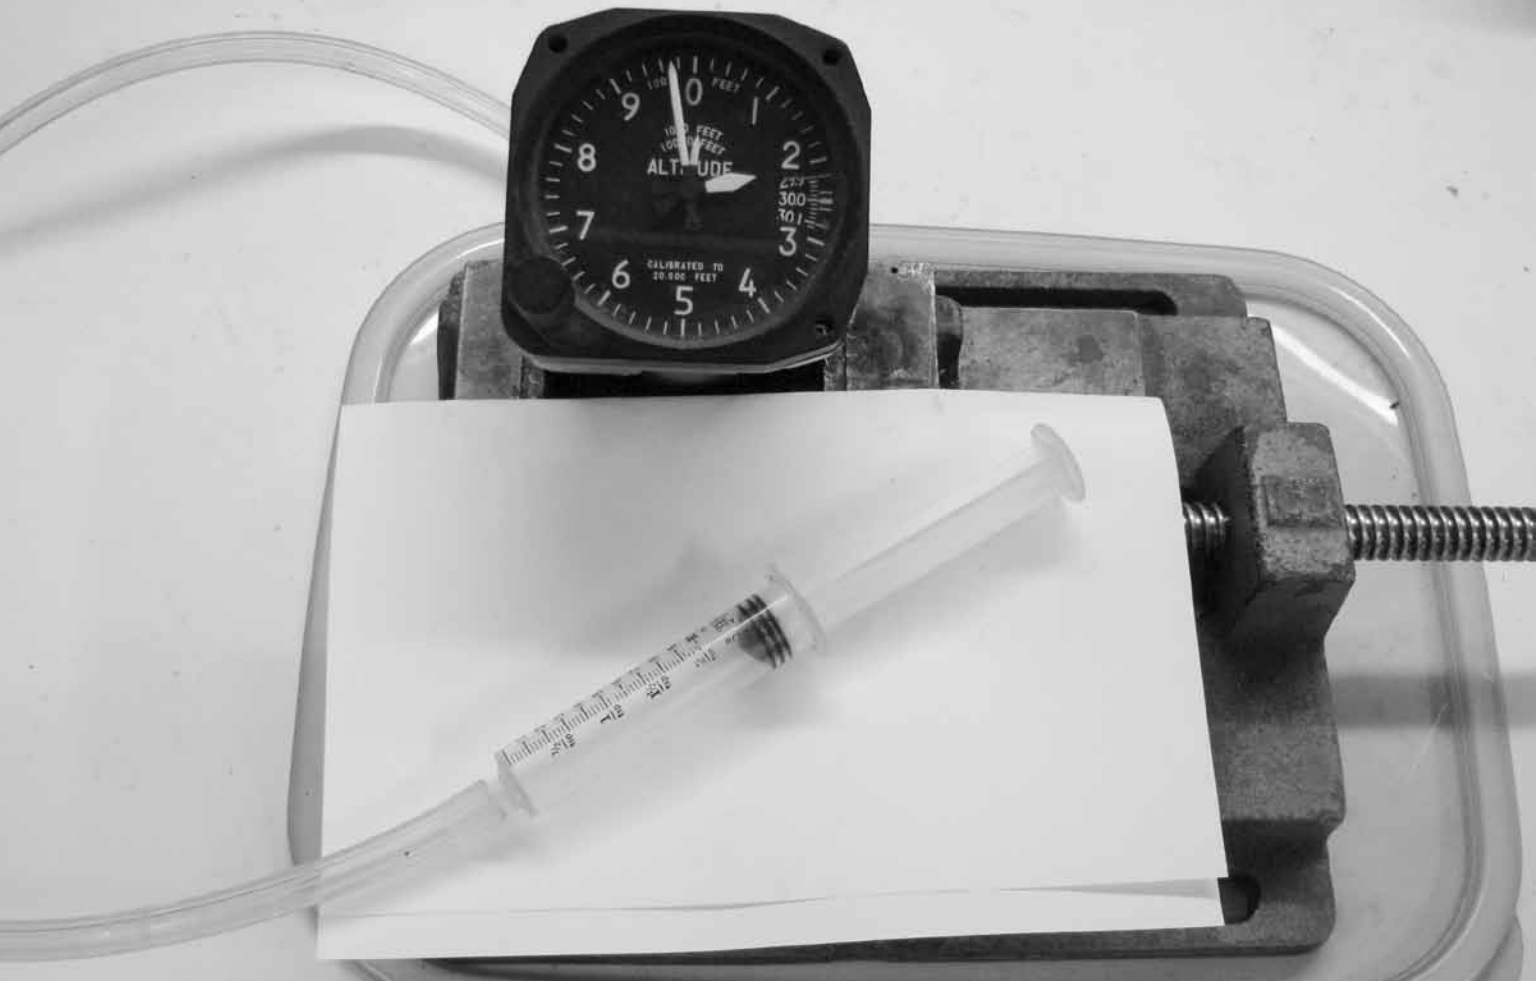
It is not difficult to adjust the Kollsman knob. Set the field elevation in the window and get the altimeter setting number from ATIS. Next to the adjuster knob on the face of the raised boss is a screw that must be removed. If you look inside the hole you will see a pin with a threaded hole, the threads into which your face screw was fitted.

Now that the face screw has been removed the pin can be slid out about 1/16" using a paper clip or a small jeweller's screwdriver. This will then release the adjuster knob and it can be pulled away from the altimeter about 1/8", which is enough to release its gear from the altimeter geartrain. It will still be engaged with the geartrain for the Kollsman window, so you can just turn the Kollsman window to the current setting number.

Gently push the knob back in to engage the altimeter geartrain. You might have to wiggle it slightly. Once it is home you can push the retaining pin back in, and check that the knob can no longer be pulled out. Set the pin's slot to position the threaded hole and gently refit the face screw.

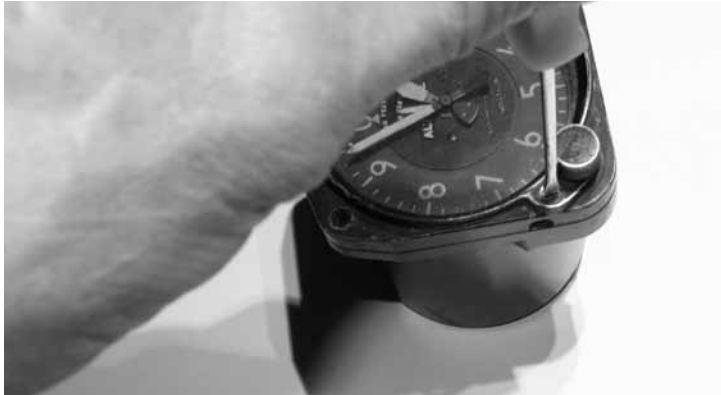
*Above: Begin by setting the field elevation, then removing the brass screw that holds the lockpin.*

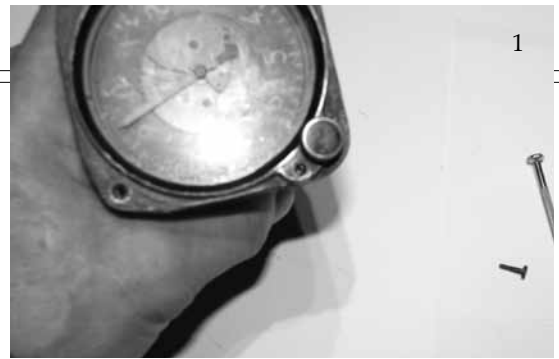
*Fig 1: Look in the hole and you will see the threaded hole in the lockpin.*

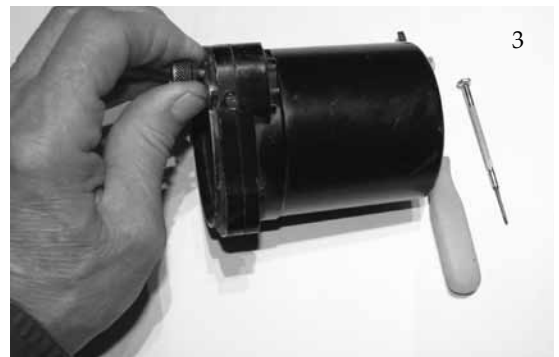
*Fig 3: Now pull the adjuster knob outwards. It will click and move 1/8". This uncouples the altimeter but retains engagement with the Kollsman.*

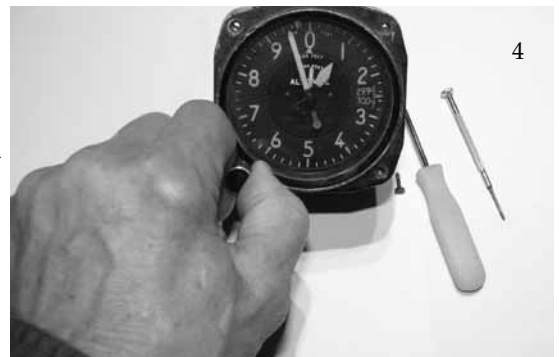
*Fig 4: Keep the knob pulled out while adjusting the Kollsman to correspond to the ATIS altimeter setting*

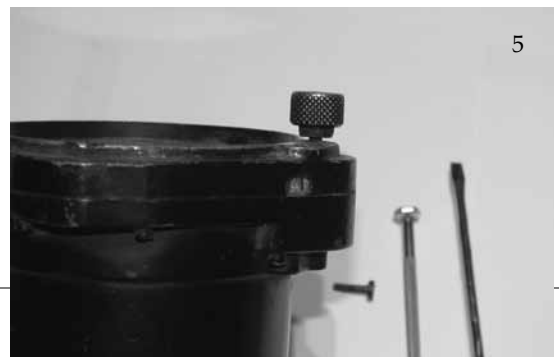
*Fig 5: re-engage the gear and push the lockpin back in place. Ensure that the threaded hole is aligned to receive the screw. On this altimeter the slot aligns with the axis of the threaded hole.*
